Snowmass Misfire Incident

Two incidents prompt in-depth review

Story and photos by John Brennan

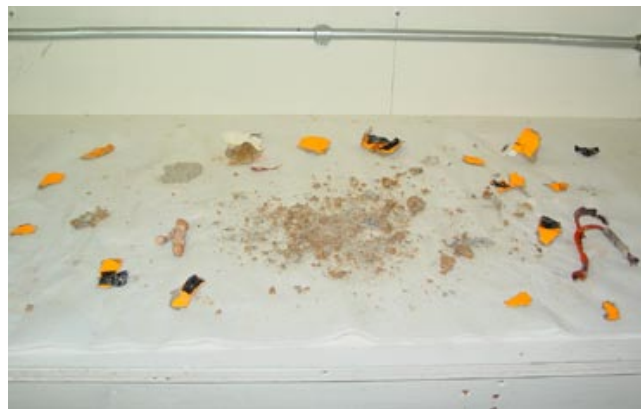
Above: Material retrieved from the misfire site.

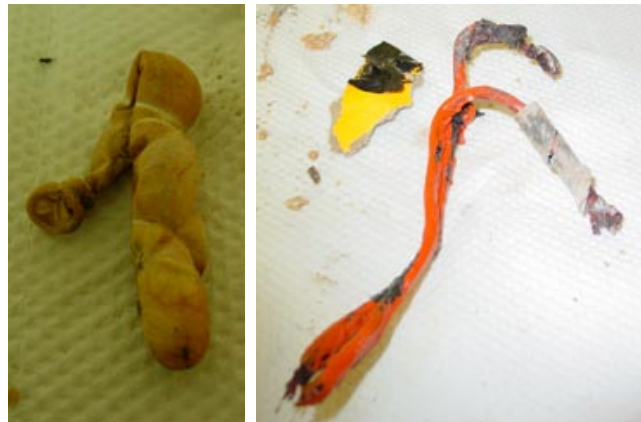
Left: The balloon that contains the sensitizing compound for the bulk of the cast shot was found about 30 feet from the blast crater. Notice the striations left from the rubber band.

Right: The thawed out cap/fuse assembly clearly shows the end of the blasting caps where they are crimped to the fuses as well as at least an inch and a half of the cardboard tube detonator wells – showing that the detonators were properly installed.

Austin Powder uses a small balloon filled with PETN for the job. PETN, which can be ignited with blasting caps, is typically the core load in detonating cord. PETN is also used in an approximate 50/50 ratio with TNT to form the cap-sensitive cast explosive called Pentolite. The balloon is held in place between the cardboard detonator wells by a rubber band. While it is uncommon for the sensitizing balloon to somehow relocate itself, it is not unheard of. This is what occurred in the booster that resulted in the misfire at Snowmass.
